DDASaccident104

Humanitarian Demining Accident and Incident Database
AID

DDAS Accident Report

Report date: 15/05/2006	Accident number: 104
Accident time: not recorded	Accident Date: 06/04/1997
Where it occurred: Kock Kin Village, Kabul Province	Country: Afghanistan
Primary cause: Field control inadequacy (?)	Secondary cause: Victim inattention (?)
Class: Other	Date of main report: [No date recorded]
ID original source: none	Name of source: MAPA/UNOCHA
Organisation: Name removed	
Mine/device: PMN AP blast	Ground condition: agricultural (abandoned) clay grass/grazing area soft
Date record created: 12/02/2004	Date last modified: 12/02/2004
No of victims: 1	No of documents: 1

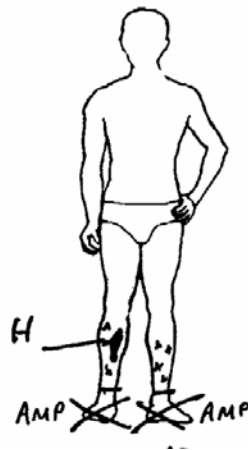
The victim's injuries were summarised as amputation of both legs and injuries to other parts of his body. A medical report recorded that "both legs of the victim have been cut from the tibia", and that there were deep injuries to the tibia on the right leg.

A medic's sketch is reproduced below.
